**Flood Control Project Maintenance
Levee Inspections****LMA District Cover Sheet****Spring 2013 Levee Inspection Results****Reclamation District No. 2085 Kasson**

Levee Inspection Report By Mile - Spring 2013

Waterway				Bank	Unit Miles	Inspection Start/End	Inspector
Unit No. 01 San Joaquin River				Left	5.20	04/09/2013 04/09/2013	Maksim Khashchuk

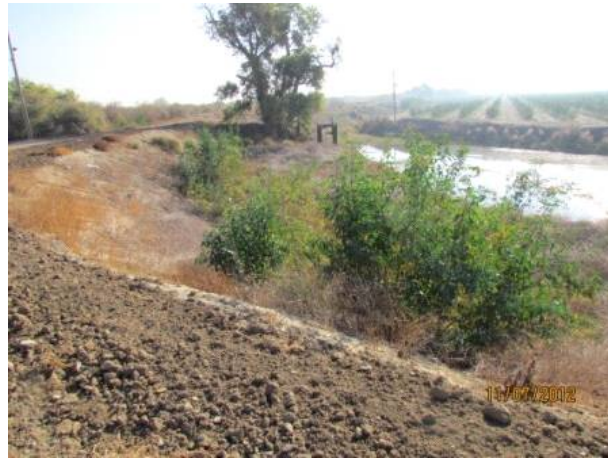
Levee Mile Report Line	4
Start Levee Mile	0.41
End Levee Mile	0.64
Location	Land Side
Category	
Item	Vegetation
View of tall vegetation on landside slope obstructing visibility.	
mkhashch_s_20130225_447.JPG

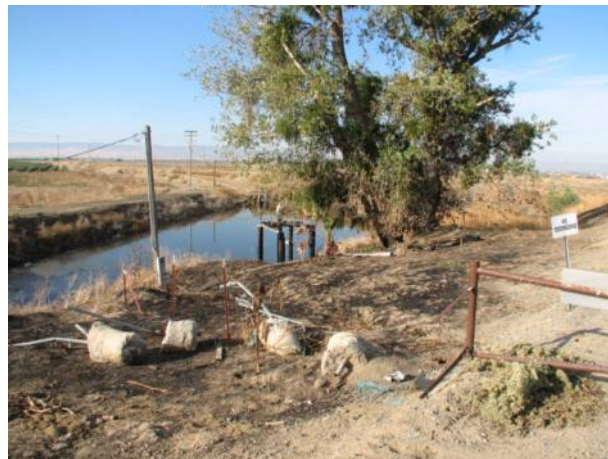
Levee Mile Report Line	5
Start Levee Mile	0.47
End Levee Mile	0.47
Location	Water Side
Category	
Item	Encroachments
Drainage discharge pipe penetrates levee with no closure device.	
mkhashch_s_20130225_448.jpg

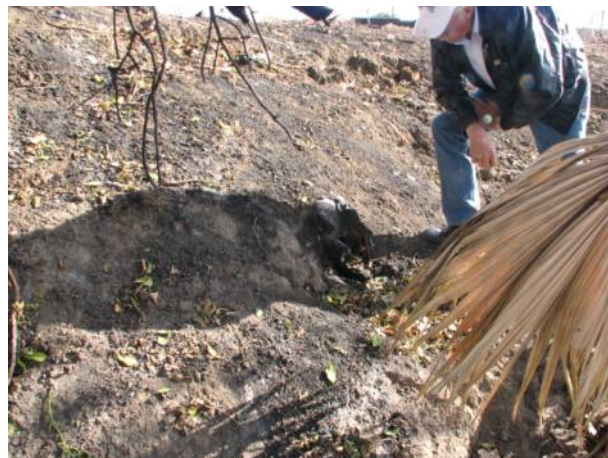
Levee Mile Report Line	5
Start Levee Mile	0.47
End Levee Mile	0.47
Location	Water Side
Category	
Item	Encroachments
Opening on landside appears to consist of melted poly pipe halfway up levee slope. Opening on waterside is heavily corroded steel pipe.	
mkhashch_s_20130225_449.jpg

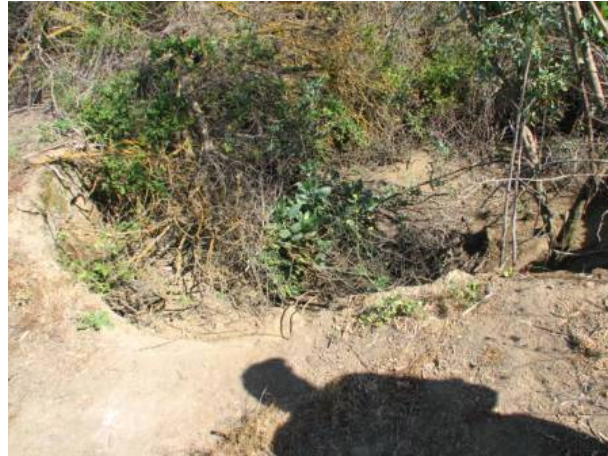
Levee Mile Report Line	5
Start Levee Mile	0.47
End Levee Mile	0.47
Location	Water Side
Category	
Item	Encroachments
04/28/2011 Area around discharge pipe appears to be in an area of erosion. Area was found after weeds were cleared.	
mkhashch_s_20130225_450.jpg

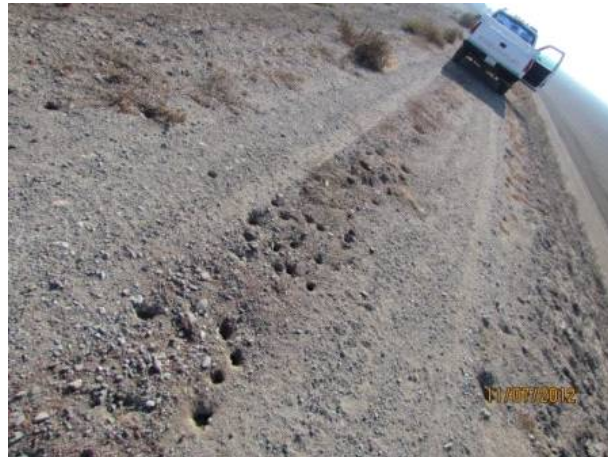
DWR ID: DWR_RD2085_01_s_2012_5									
7	1.15	1.15		Animal Control	CR M Ma	A3 : No rodents visible, but rodent burrows visible; need to backfill and compact or grout burrows. Inspector Comments: Multiple rodent burrows on crown.	37.715820 ° -121.291183 °	37.715820 ° -121.291183 °	25 Y
DWR ID: DWR_RD2085_01_f_2012_25									
8	1.18	1.18		Animal Control	LS M Ma	A3 : No rodents visible, but rodent burrows visible; need to backfill and compact or grout burrows. Inspector Comments: 6-7 burrows present near levee toe.	37.715569 ° -121.290892 °	37.715569 ° -121.290892 °	40 Y
DWR ID: DWR_RD2085_01_s_2012_40									
9	1.28	1.32		Encroachments	LS M En	DT : Ditch Inspector Comments: Drainage ditch at levee toe.	37.714265 ° -121.289641 °	37.714056 ° -121.289069 °	6 Y
DWR ID: DWR_RD2085_01_s_2012_6									
10	1.29	1.29		Encroachments	WSA/W U En	PI : Pipe	37.714400 ° -121.289466 °	37.714400 ° -121.289466 °	21 Y

Levee Mile Report Line	7
Start Levee Mile	1.15
End Levee Mile	1.15
Location	Crown
Category	
Item	Animal Control
View of multiple rodent burrows on levee crown.	
mkhashch_s_20130225_456.JPG

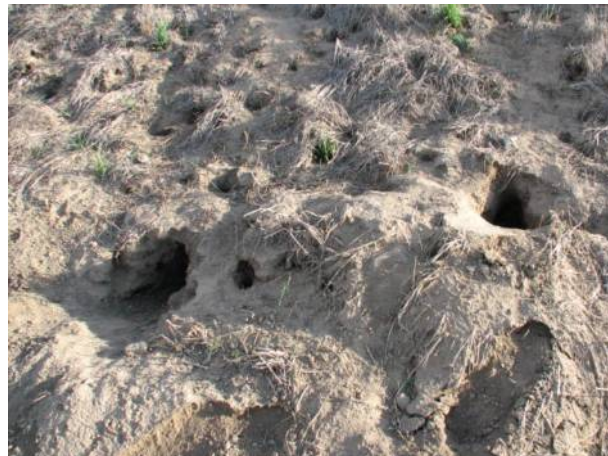
Levee Mile Report Line	8
Start Levee Mile	1.18
End Levee Mile	1.18
Location	Land Side
Category	
Item	Animal Control
11/03/2011 Several burrows present.	
mkhashch_s_20130225_466.jpg

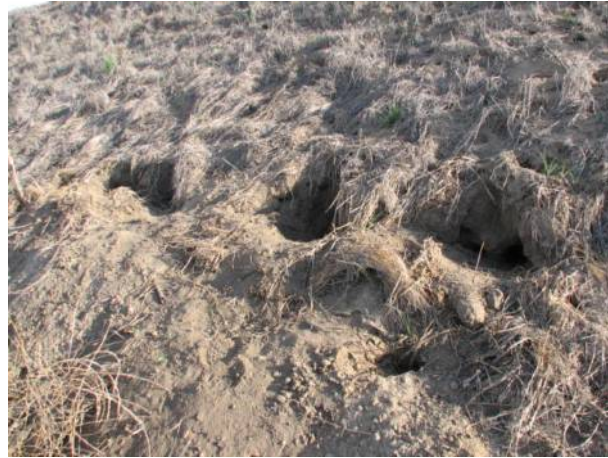
Levee Mile Report Line	8
Start Levee Mile	1.18
End Levee Mile	1.18
Location	Land Side
Category	
Item	Animal Control
11/03/2011 Second photo more burrows in the same location.	
mkhashch_s_20130225_467.jpg

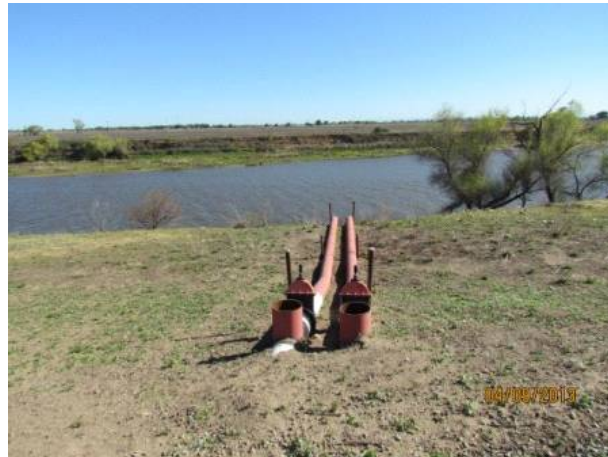
Levee Mile Report Line	10
Start Levee Mile	1.29
End Levee Mile	1.29
Location	Water Side
Category	
Item	Encroachments
View of the pipe penetrating the waterside levee slope.	
mkhashch_s_20130410_713.JPG

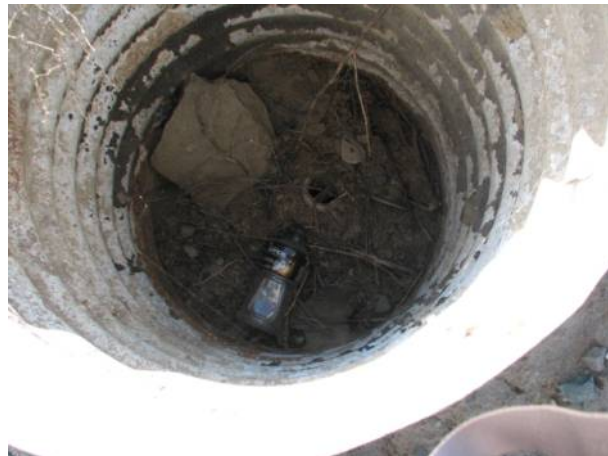
Levee Mile Report Line	11
Start Levee Mile	1.35
End Levee Mile	1.35
Location	Water Side
Category	
Item	Encroachments
Photo of anti siphon at waterside shoulder.	
mkhashch_s_20130225_451.jpg

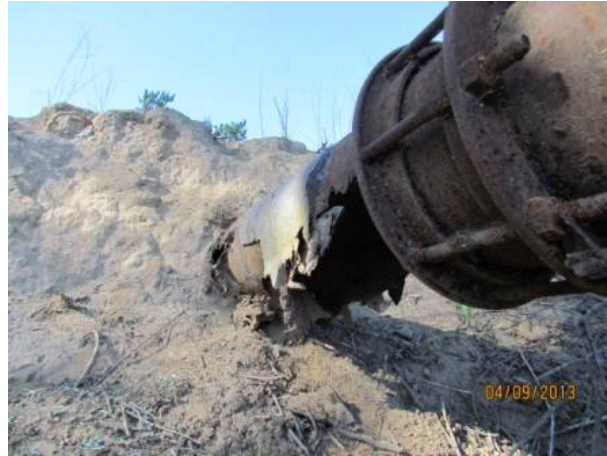
DWR ID: DWR_RD2085_01_s_2013_21									
11	1.35	1.35		Encroachments	WS U En	PI : Pipe Inspector Comments: The pipe has corroded and caused several sinkholes in the waterside slope and berm.	37.714048 ° -121.288410 °	37.714048 ° -121.288410 °	8 Y
DWR ID: DWR_RD2085_01_s_2012_8									
12	1.98	2.11		Vegetation	WS M Ma	V1 : Control annual grass and weeds on the levee slopes and easements.	37.708839 ° -121.279272 °	37.708151 ° -121.277097 °	26 Y
DWR ID: DWR_RD2085_01_s_2013_26									
13	1.98	1.98		Encroachments	WSA/W U En	PI : Pipe	37.708838 ° -121.279253 °	37.708838 ° -121.279253 °	17 Y
DWR ID: DWR_RD2085_01_s_2012_17

Levee Mile Report Line	11
Start Levee Mile	1.35
End Levee Mile	1.35
Location	Water Side
Category	
Item	Encroachments
View of the corroded pipe day lighting at the waterside berm.	
mkhashch_s_20130410_714.JPG

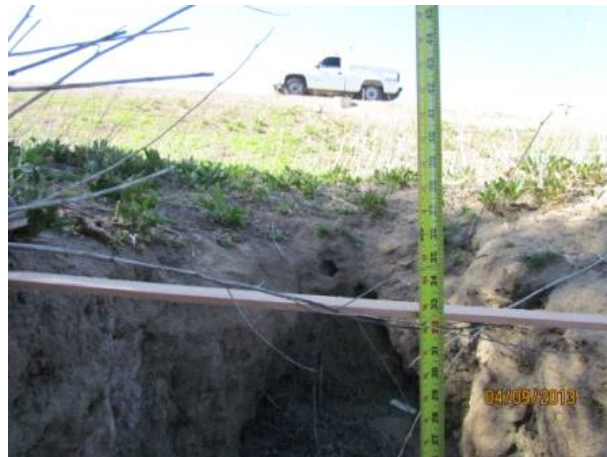
Levee Mile Report Line	11
Start Levee Mile	1.35
End Levee Mile	1.35
Location	Water Side
Category	
Item	Encroachments
View of the sinkhole at the waterside berm and slope. The sinkhole is approximately 36" wide by 70" long by 32" deep.	
mkhashch_s_20130410_715.JPG

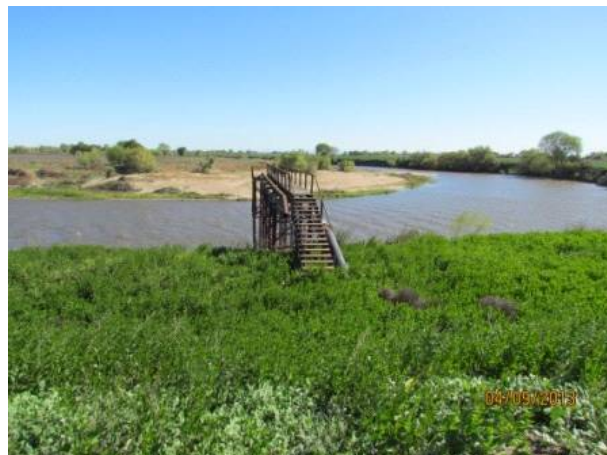
Levee Mile Report Line	13
Start Levee Mile	1.98
End Levee Mile	1.98
Location	Water Side
Category	
Item	Encroachments
View of the pipe day lighting at waterside levee toe.	
mkhashch_s_20130410_716.JPG

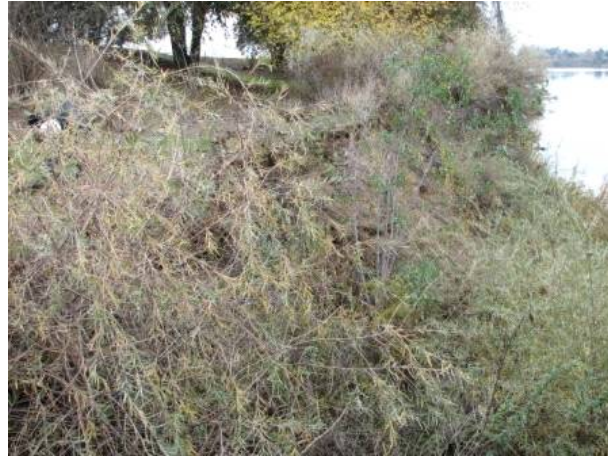
Levee Mile Report Line	17
Start Levee Mile	2.49
End Levee Mile	2.52
Location	Water Side
Category	Supplemental
Item	DWR Erosion Survey

Looking downstream

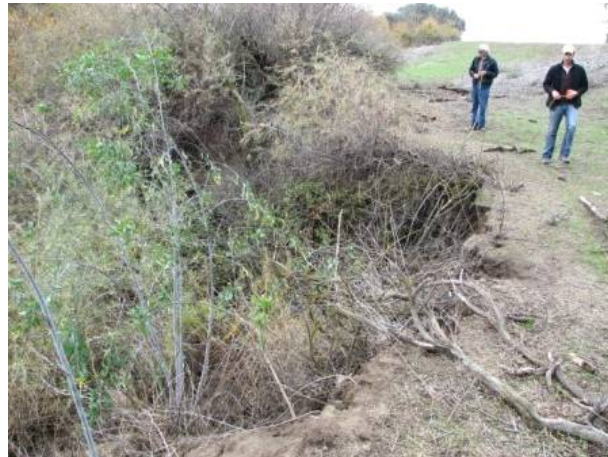
Levee Mile Report Line	17
Start Levee Mile	2.49
End Levee Mile	2.52
Location	Water Side
Category	Supplemental
Item	DWR Erosion Survey

Looking upstream

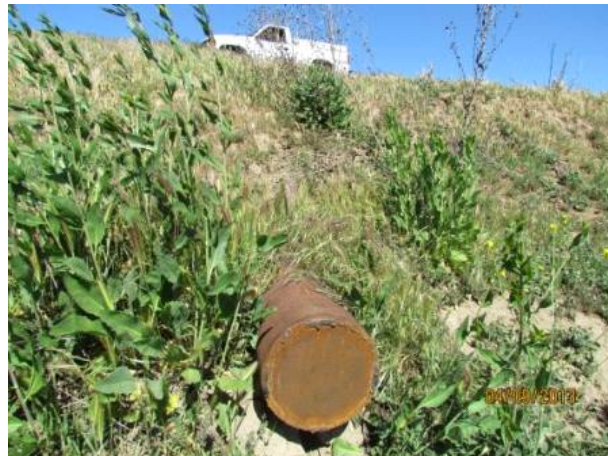
Levee Mile Report Line	20
Start Levee Mile	3.22
End Levee Mile	3.22
Location	Water Side
Category	
Item	Encroachments

View of the pipe capped at the waterside slope.

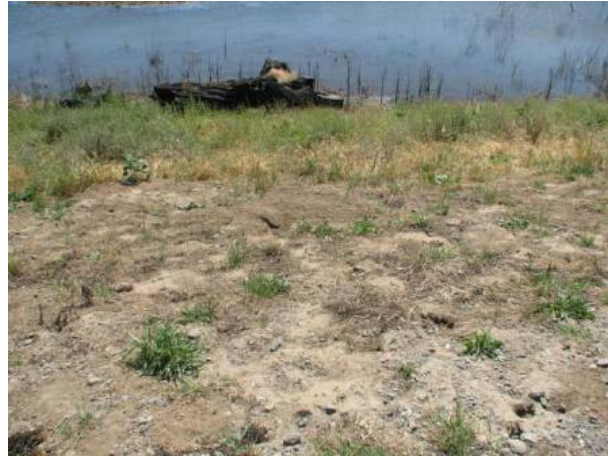
Levee Mile Report Line	21
Start Levee Mile	3.28
End Levee Mile	3.28
Location	Water Side
Category	
Item	Animal Control
04/28/2011 Fresh burrow in center of picture, "porch" extends to the grass line.	
mkhashch_s_20130225_455.jpg

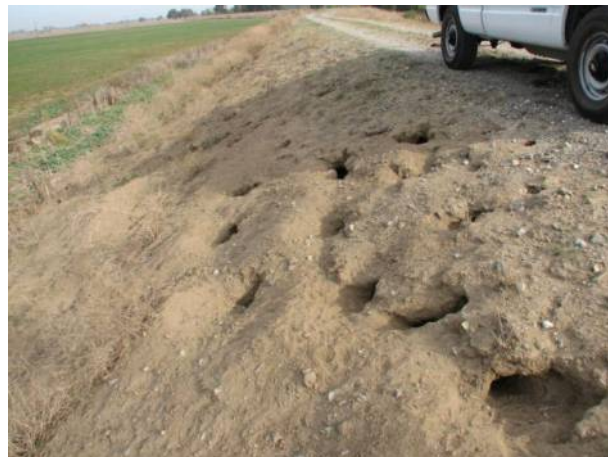
Levee Mile Report Line	22
Start Levee Mile	3.31
End Levee Mile	3.31
Location	Land Side
Category	
Item	Animal Control
11/03/2011 Landside burrows.	
mkhashch_s_20130225_469.jpg

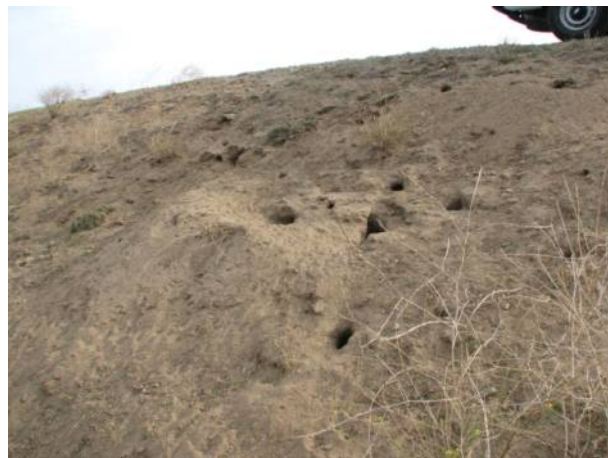
Levee Mile Report Line	22
Start Levee Mile	3.31
End Levee Mile	3.31
Location	Land Side
Category	
Item	Animal Control
11/03/2011 More landside burrows at same location.	
mkhashch_s_20130225_470.jpg

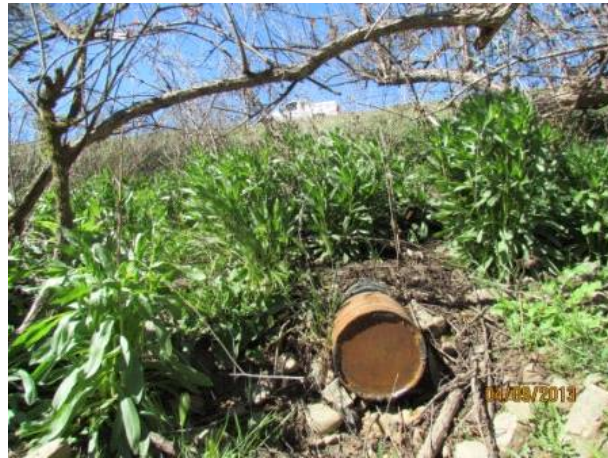
Levee Mile Report Line	23
Start Levee Mile	3.33
End Levee Mile	3.33
Location	Water Side
Category	
Item	Encroachments

DWR ID: DWR_RD2085_01_s_2012_44										
23	3.33	3.33		Encroachments	WSA/W En	PI : Pipe	Inspector Comments: Pipe capped with a steel plate on waterside end.	37.691969 ° -121.278093 °	37.691969 ° -121.278093 °	22 Y
DWR ID: DWR_RD2085_01_s_2012_22										
24	3.37	3.37		Animal Control	LS Ma	M	A3 : No rodents visible, but rodent burrows visible; need to backfill and compact or grout burrows.	37.691680 ° -121.277925 °	37.691680 ° -121.277925 °	47 Y
DWR ID: DWR_RD2085_01_s_2012_47

View of the pipe capped at the waterside end.

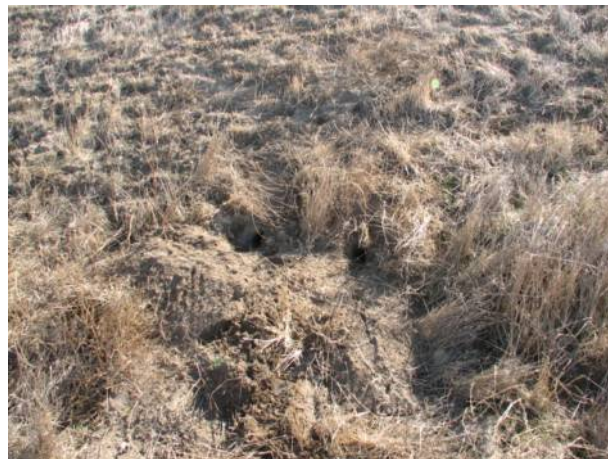
Levee Mile Report Line	24
Start Levee Mile	3.37
End Levee Mile	3.37
Location	Land Side
Category	
Item	Animal Control

Rodent holes have been flagged for repair.

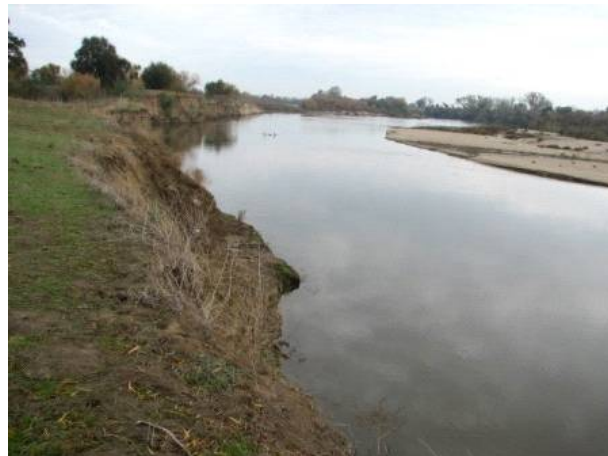
Levee Mile Report Line	27
Start Levee Mile	3.58
End Levee Mile	3.71
Location	Water Side
Category	Supplemental
Item	DWR Erosion Survey

Looking downstream. At the downstream end the erosion occurring at a spur levee.

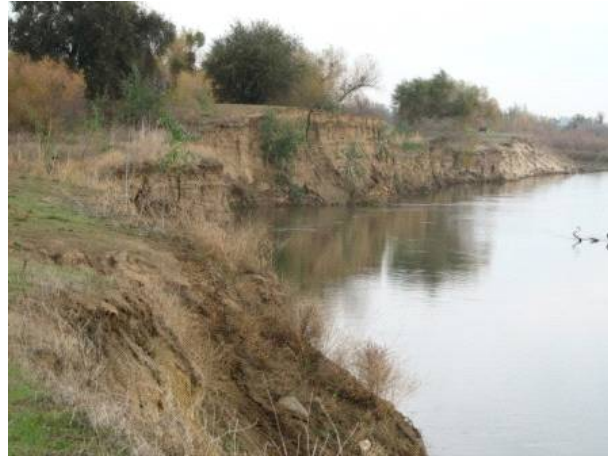
Levee Mile Report Line	27
Start Levee Mile	3.58
End Levee Mile	3.71
Location	Water Side
Category	Supplemental
Item	DWR Erosion Survey
Looking downstream at the erosion at the spur levee	
mkhashch_s_20130225_465.jpg

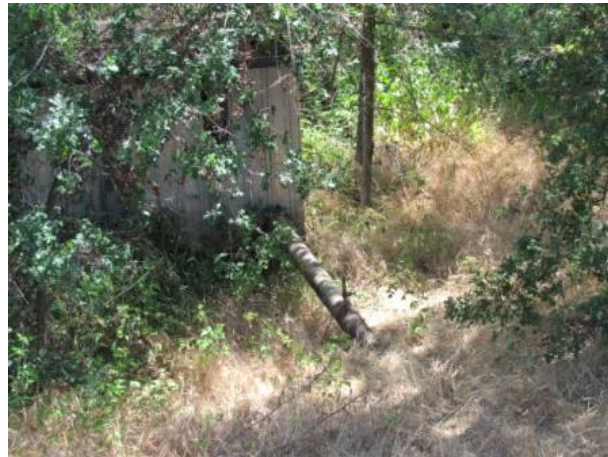
Levee Mile Report Line	32
Start Levee Mile	3.95
End Levee Mile	3.95
Location	Crown
Category	
Item	Encroachments
View of pipe penetrating waterside slope. 05/16/2012	
mkhashch_s_20130225_452.jpg

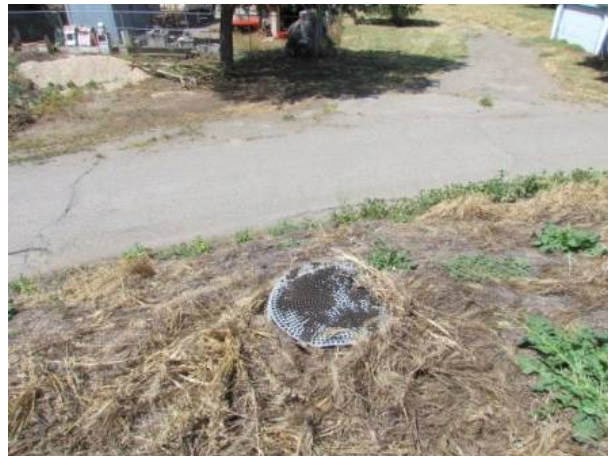
Levee Mile Report Line	32
Start Levee Mile	3.95
End Levee Mile	3.95
Location	Crown
Category	
Item	Encroachments
View of siphon breaker valve on landside hinge. 05/16/2012	
mkhashch_s_20130225_453.jpg

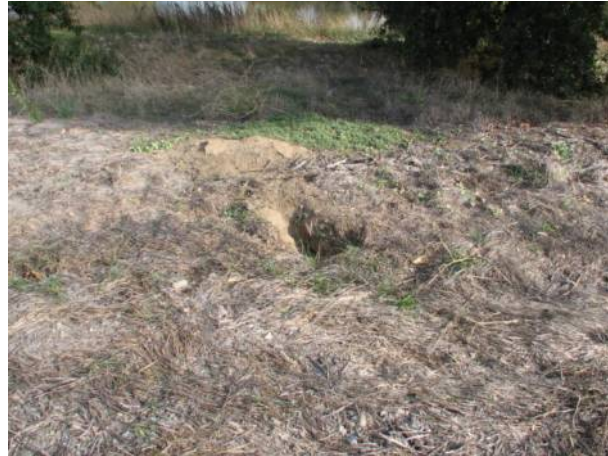
DWR ID: DWR_RD2085_01_s_2012_10		
33	3.98	3.98		Animal Control	WS	M Ma	A3 : No rodents visible, but rodent burrows visible; need to backfill and compact or grout burrows.	37.683403 ° -121.275372 °	37.683403 ° -121.275372 °	53 Y
								DWR ID: DWR_RD2085_01_s_2012_53		
34	4.14	4.14		Trim / Thin Trees	WS	C Ma	T1 : Trim trees to at least five feet above ground level.	37.682125 ° -121.272988 °	37.682125 ° -121.272988 °	28
								DWR ID: DWR_RD2085_01_s_2012_28		
35	4.18	4.45		Vegetation	WS	M Ma	V2 : Remove the wild growth other than native grasses from the levee slopes.	37.681886 ° -121.272333 °	37.681332 ° -121.267518 °	54 Y
								DWR ID: DWR_RD2085_01_s_2012_54		
36	4.23	4.33		Trim / Thin Trees	WS	C Ma	T1 : Trim trees to at least five feet above ground level.	37.681746 ° -121.271419 °	37.681882 ° -121.269607 °	29
								DWR ID: DWR_RD2085_01_s_2012_29		
37	4.28	4.28		Crown Surface / Depressions / Rutting	CR	M Ma	C2 : Repair depressions or ruts in the crown or slope.	37.681752 ° -121.270542 °	37.681752 ° -121.270542 °	42

Levee Mile Report Line	33
Start Levee Mile	3.98
End Levee Mile	3.98
Location	Water Side
Category	
Item	Animal Control
11/03/2011 Burrow on waterside.	
mkhashch_s_20130225_474.jpg

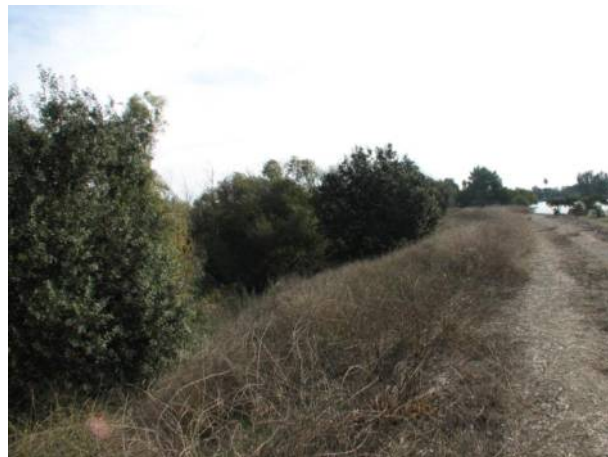
Levee Mile Report Line	35
Start Levee Mile	4.18
End Levee Mile	4.45
Location	Water Side
Category	
Item	Vegetation
11/03/2011 Waterside vegetation needs to be maintained on the top 20' of the waterside slope.	
mkhashch_s_20130225_475.jpg

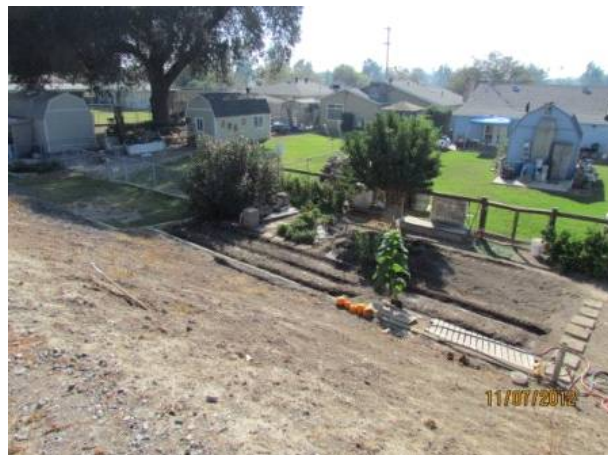
Levee Mile Report Line	39
Start Levee Mile	4.32
End Levee Mile	4.37
Location	Land Side
Category	
Item	Vegetation
Updated photo of encroachments on landside toe.	
mkhashch_s_20130225_459.JPG

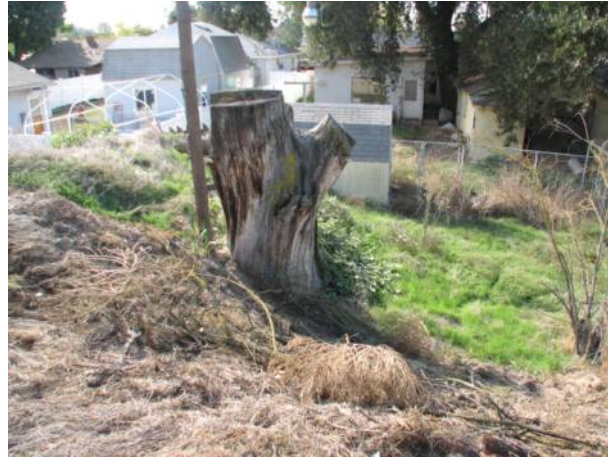
Levee Mile Report Line	41
Start Levee Mile	4.38
End Levee Mile	4.38
Location	Land Side
Category	
Item	Trim / Thin Trees
11/03/2011 Large stump on landside slope.	
mkhashch_s_20130225_458.jpg

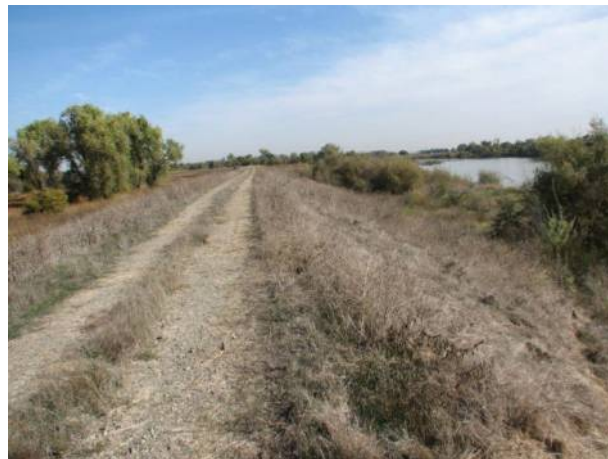
DWR ID: DWR_RD2085_01_s_2012_56										
47	4.92	5.01		Vegetation	WS	M Ma	V2 : Remove the wild growth other than native grasses from the levee slopes.	37.677882 ° -121.268440 °	37.677072 ° -121.269667 °	57 Y
DWR ID: DWR_RD2085_01_s_2012_57

Levee Mile Report Line	47
Start Levee Mile	4.92
End Levee Mile	5.01
Location	Water Side
Category	
Item	Vegetation
11/03/2011 Waterside vegetation has been sprayed, but needs to be removed so the top 20' of the slope is visible.	
mkhashch_s_20130225_478.jpg

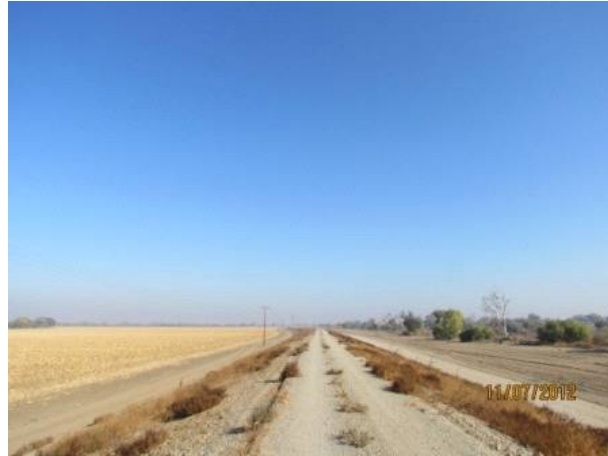
View of tall vegetation obstructing visibility of waterside slopes.

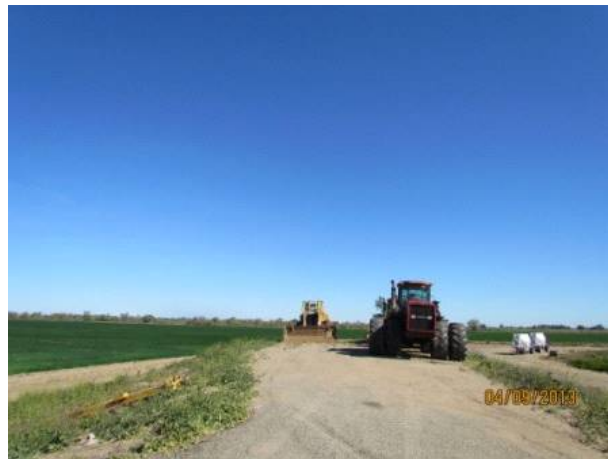
Levee Mile Report Line	2
Start Levee Mile	0.67
End Levee Mile	0.67
Location	Crown
Category	
Item	Encroachments

View of farming equipment being stored on the levee crown at the end of the spur levee.

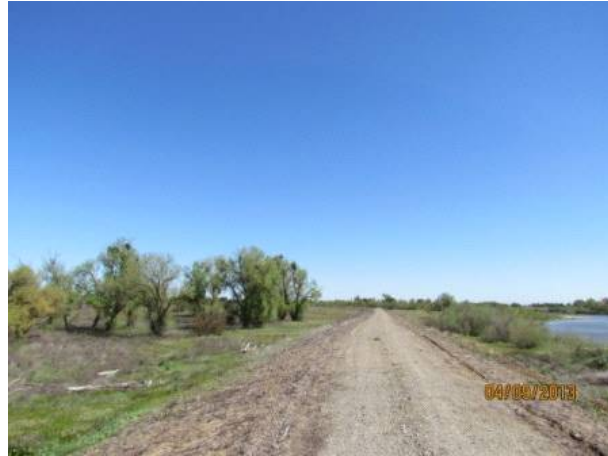
View of vegetation on waterside slope.
